"Abstract 799 ", "FIXATION OF OSTEOCHONDRAL FRACTURES FOLLOWING ACUTE PATELLA DISLOCATION: PROSPECTIVE STUDY TO ASSESS THE CLINICAL OUTCOMES AND RADIOLOGICAL UNION WITH FOLLOW UP MRI SCANS"

Vishal Rajput, Shoaib Iqbal, Mohammad Salim, Sanjeev Anand

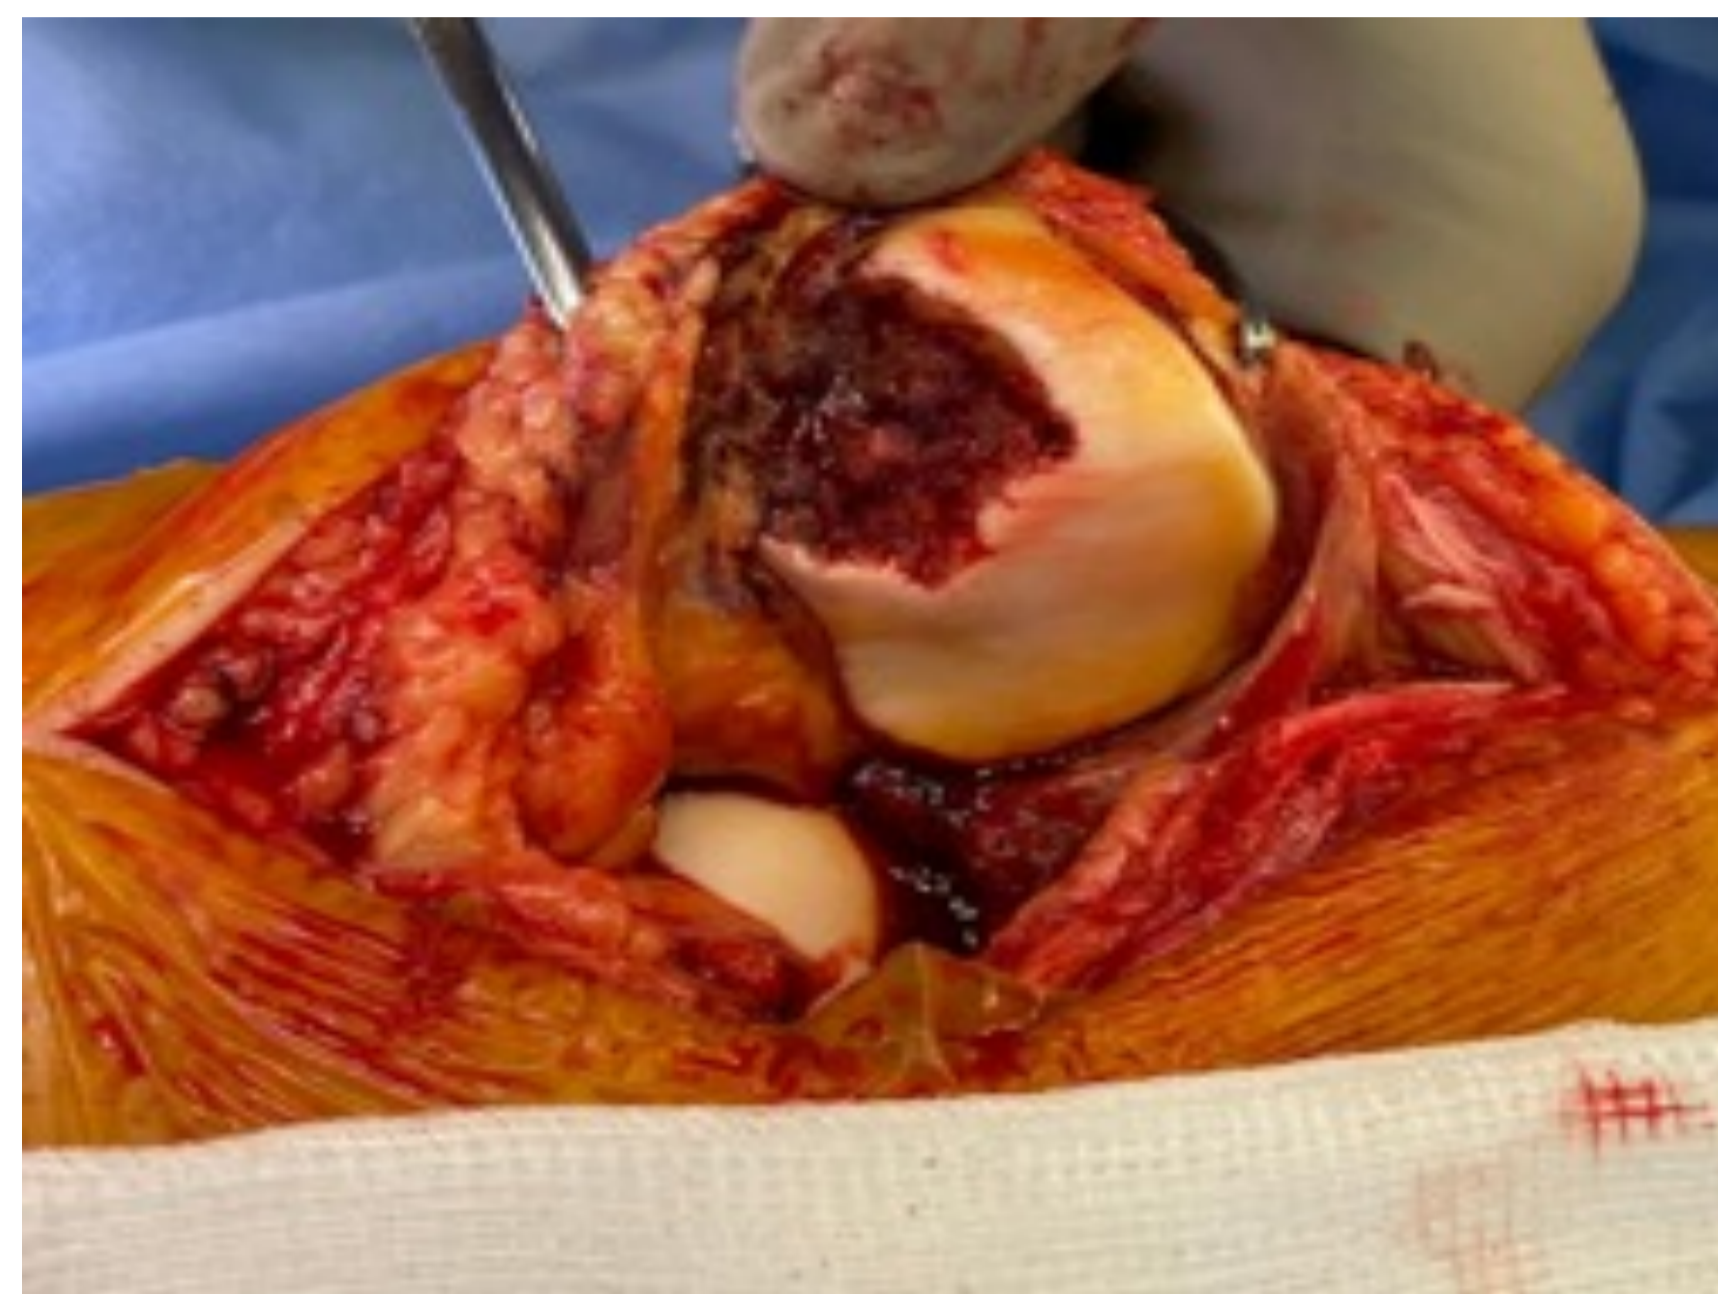
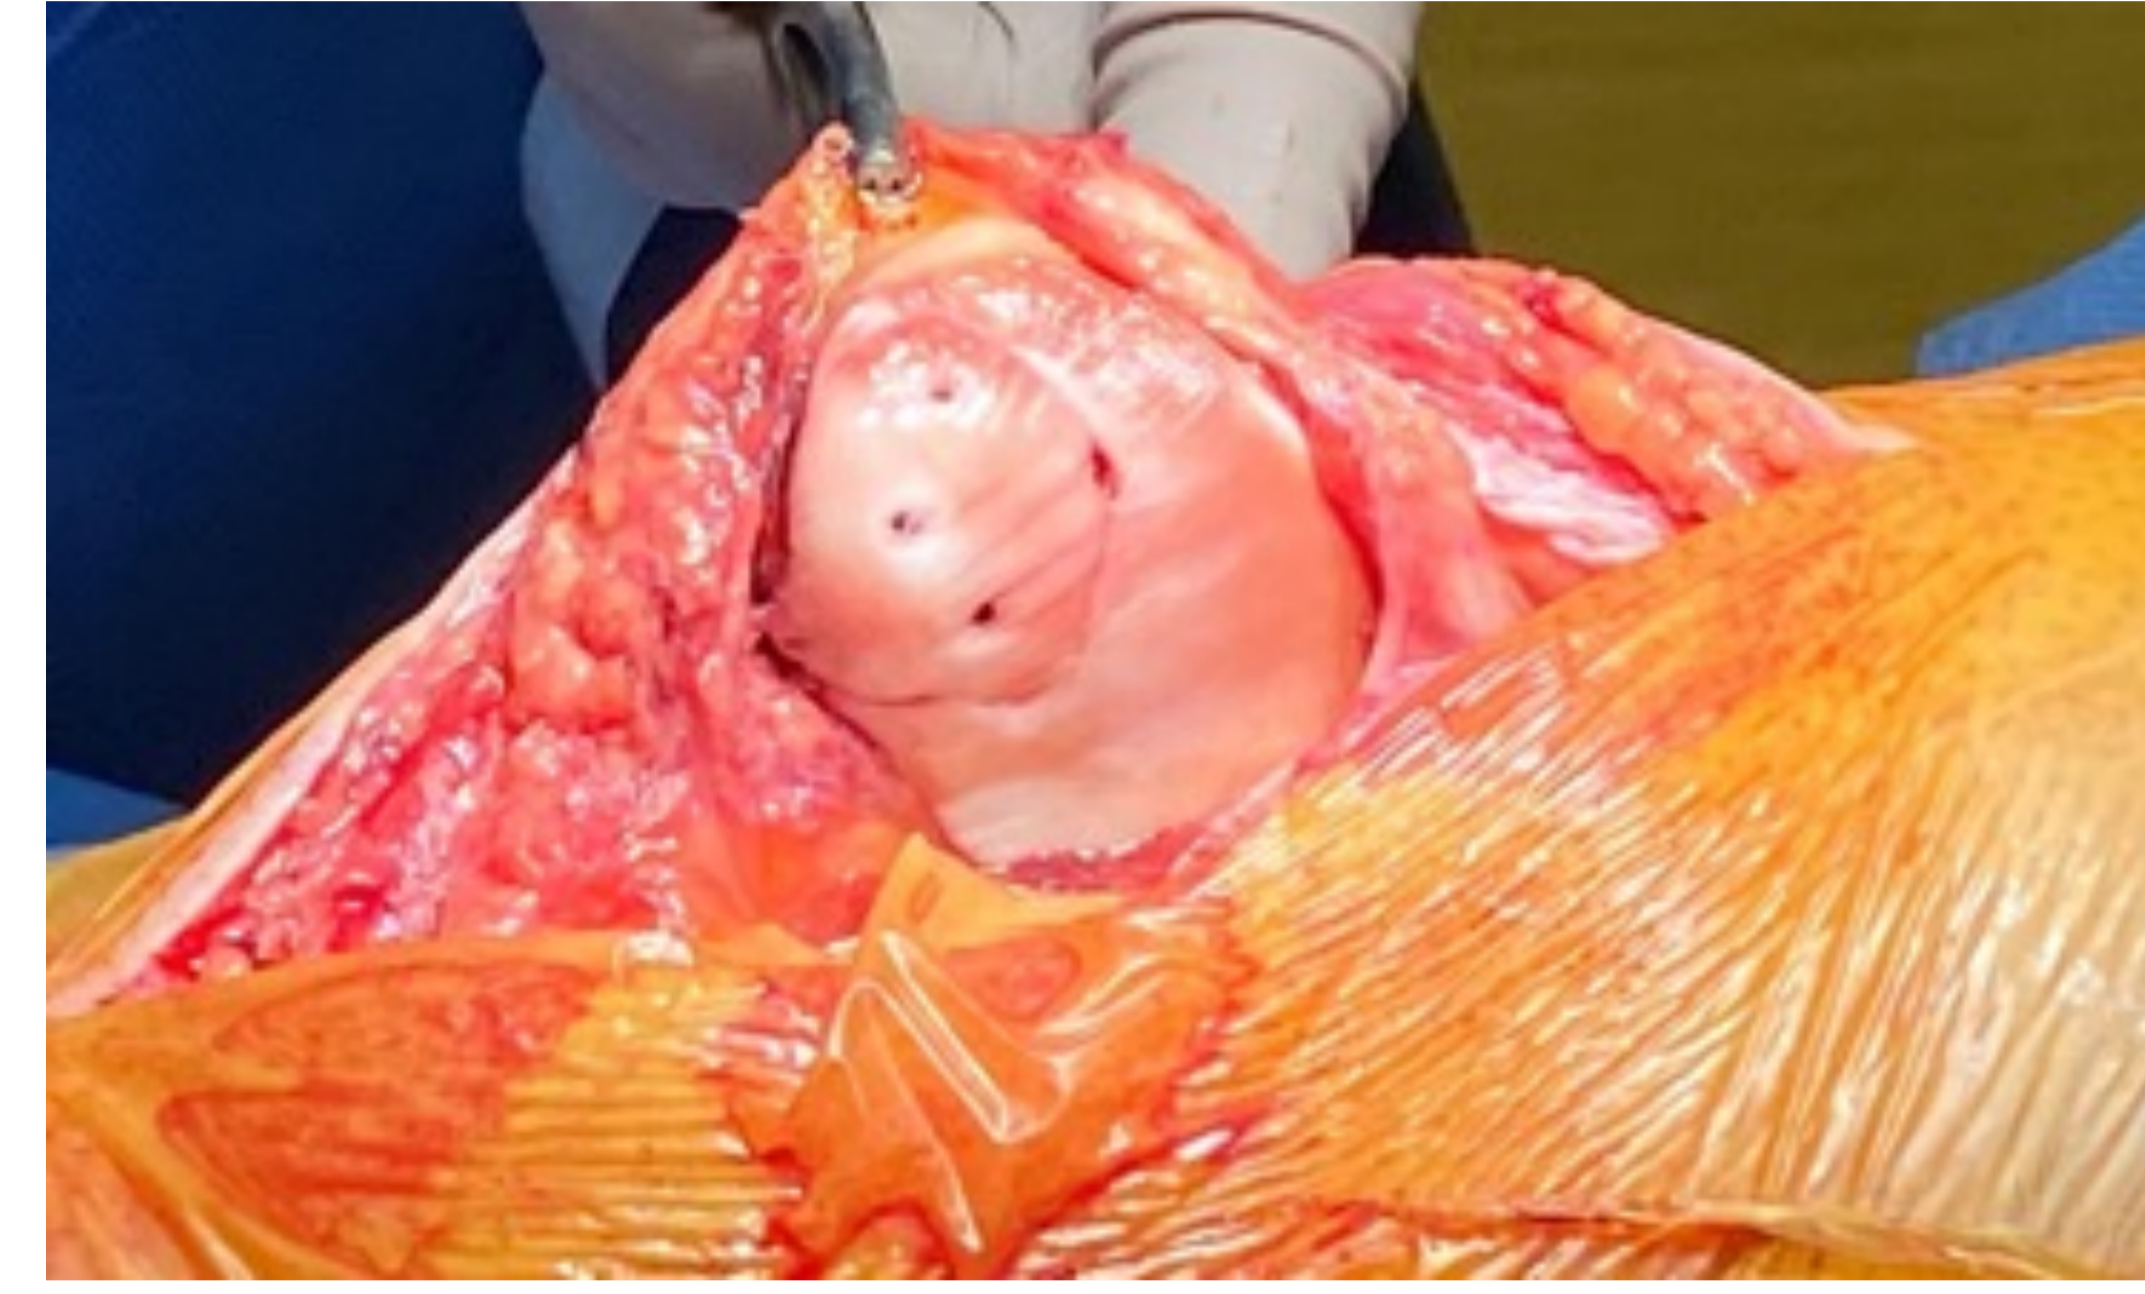
Figure 1: Intraoperative images of osteochondral fracture fixation

- 29 patients (18 male, 11 ) sustained osteochondral fractures of the knee following patellar dislocation.
- All patients had detailed radiographic imaging and MRI scan of the knee preoperatively.
- An arthroscopic assessment was done, followed by fixation using bio-absorbable pins or headless screws either arthroscopically or mini-open arthrotomy.
- VMO plication or MPFL repair were done if necessary
- FU MRI scans were done to assess healing

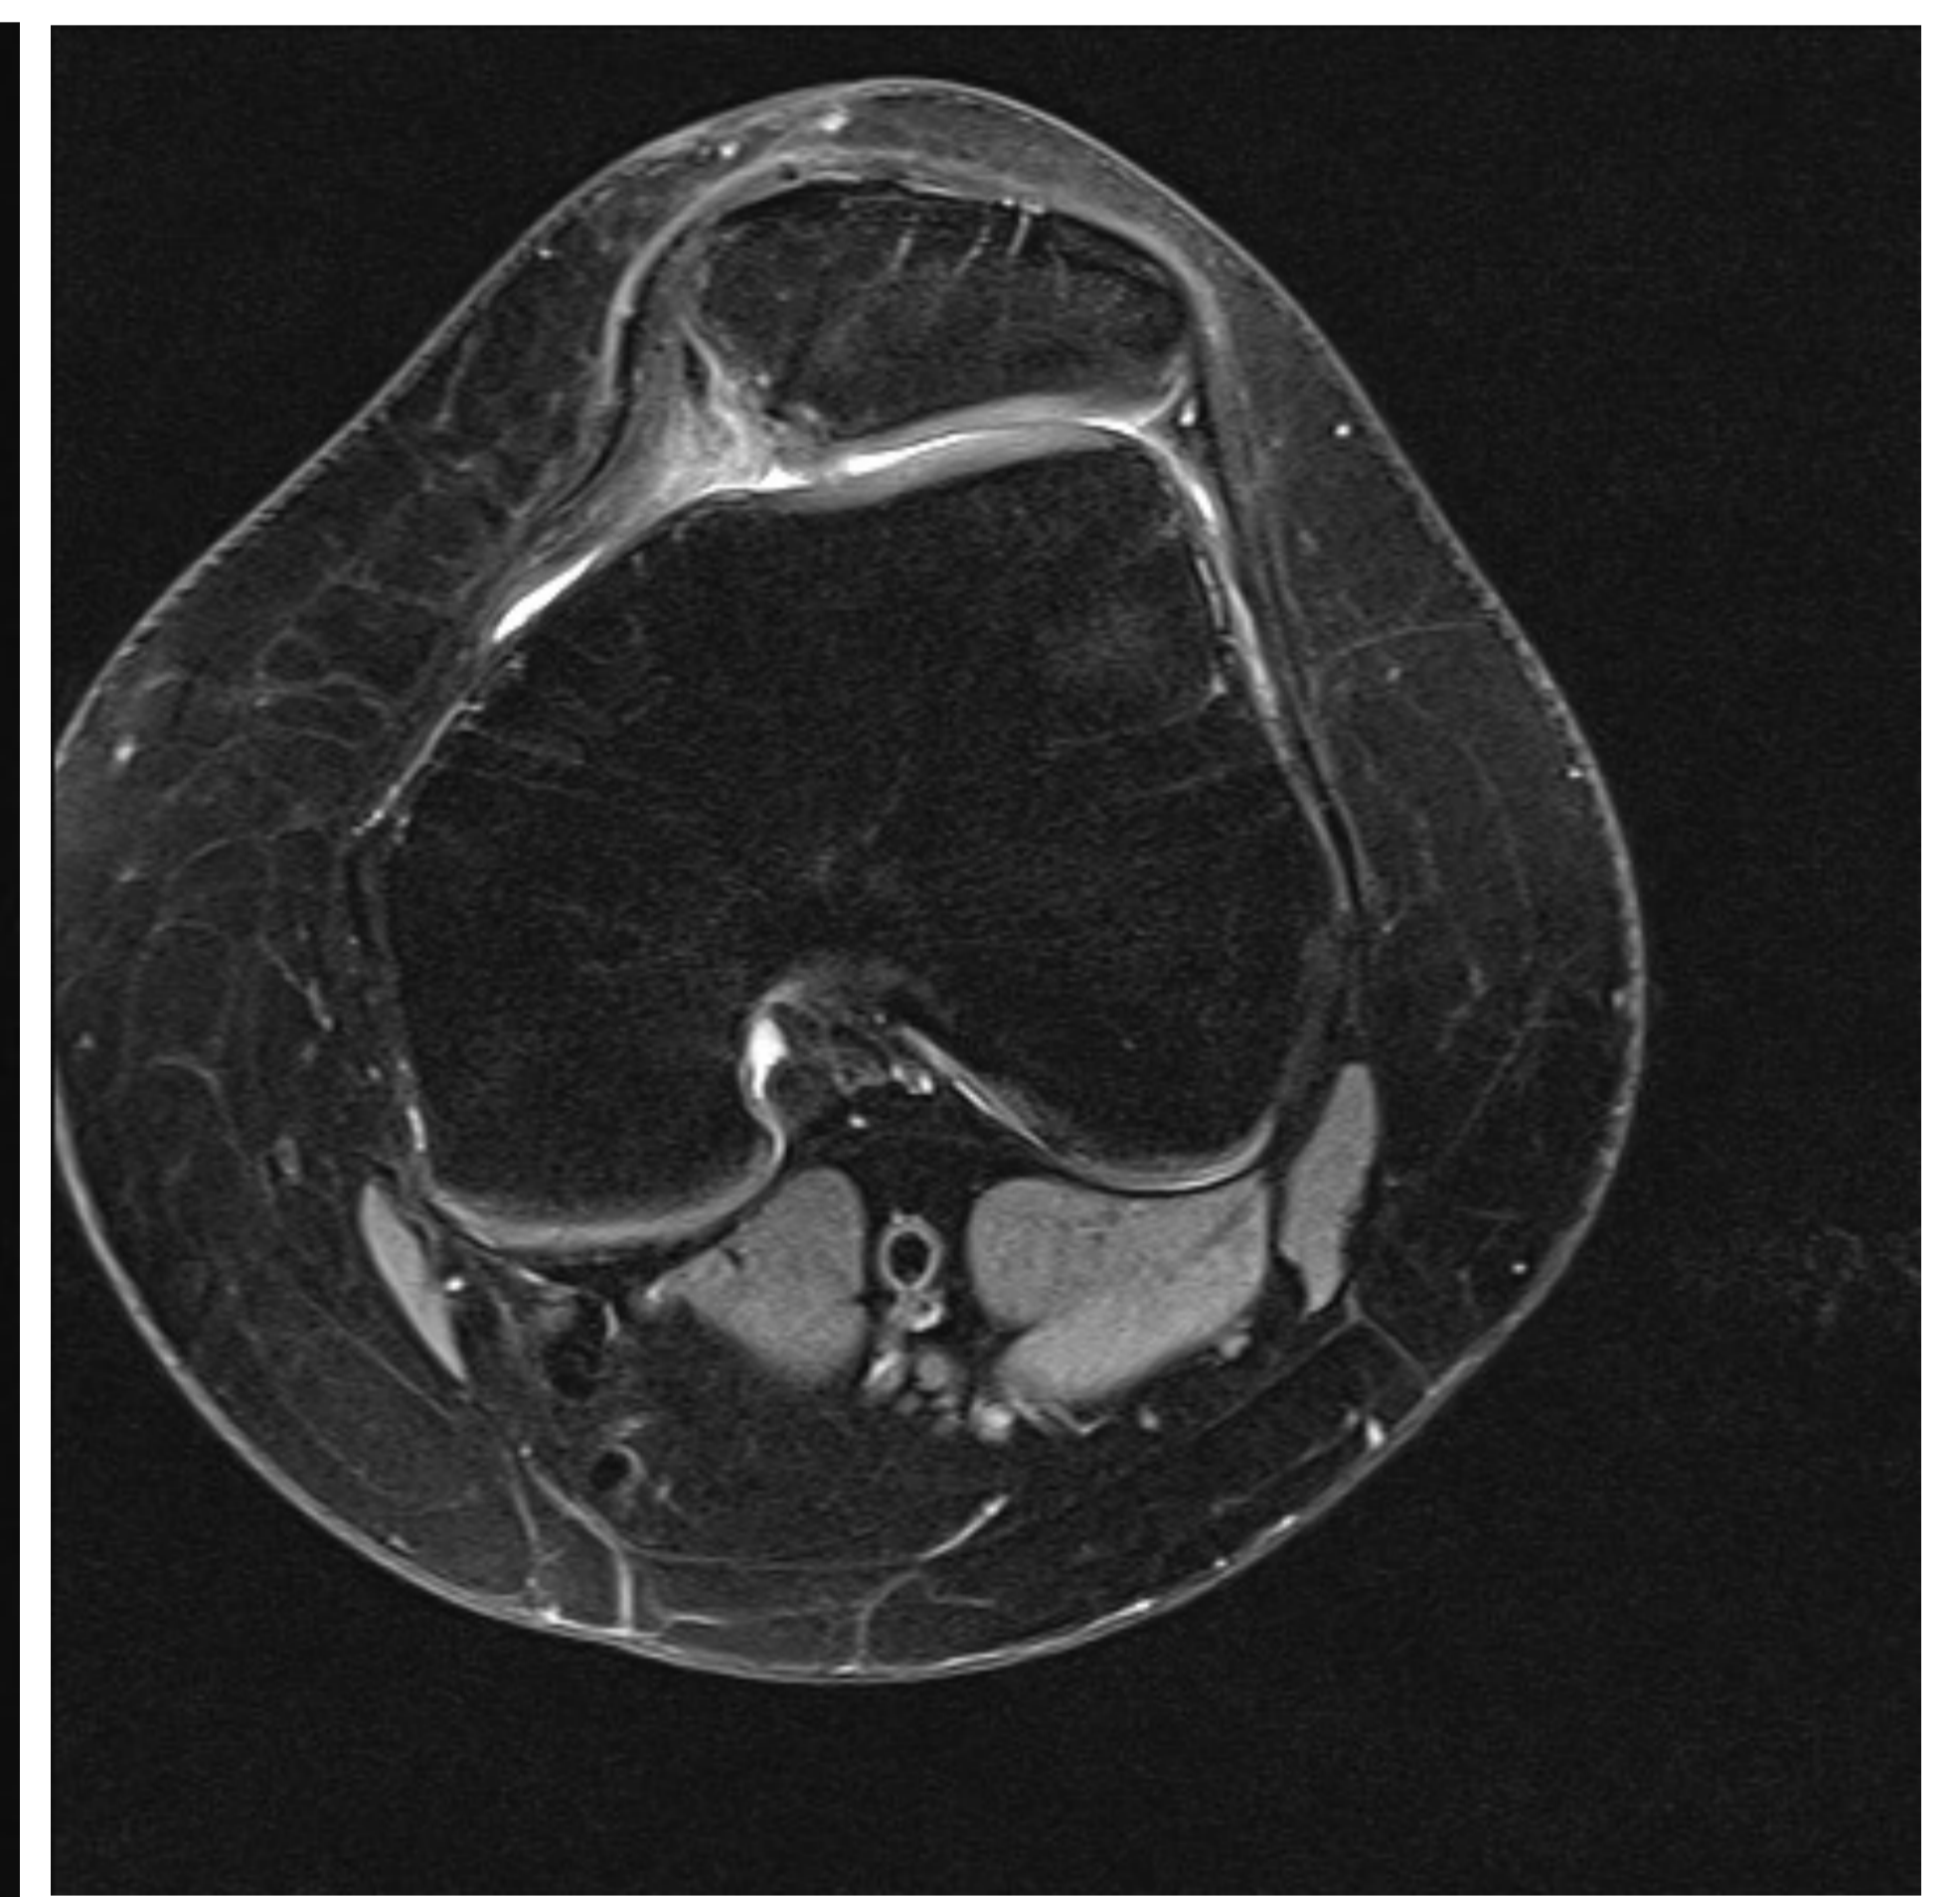
Figure 2: Pre-op and post-op MRI scans of patient with osteochondral fracture

- All patients returned to their pre-injury activity level (Mean score 7) and sports.
- None of the patients had a further episode of patellar dislocation.
- Mean postoperative IKDC score was 86.5 (SD 17.3),
- Kujala was 91.1(SD 15.5) and
- Tegner- lysholm was 88.7 (SD 14.4).
- Post-operative MRI scan showed satisfactory union in all cases (100%)
